## CSP Sewer Reline for Busy Highway Intersections

Ministry of Transportation, Ontario Underground Services Limited Morrison Hershfield Mississauga, ON

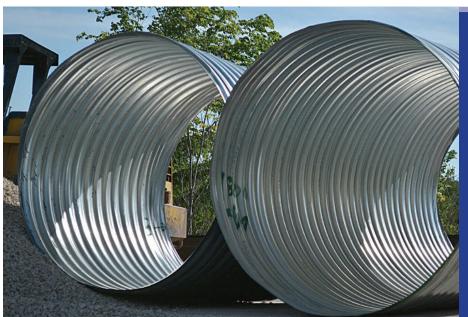
Built in 1974, this 3050mm concrete storm sewer was showing severe signs of pre-mature deterioration. For several years, the concrete sewer had been cracking; joints had been separating and corrosion of the reinforcing steel and subsequent spalling of the concrete from the interior pipe walls was becoming a major concern. The owner, the Ministry of Transportation of Ontario recognized that the storm sewer had to be rehabilitated. Replacement was impractical, if not impossible, due to its location under one of the busiest highways in Canada.

The Corrugated Steel Pipe was installed piece by piece, each piece secured in place using factory-installed screw jacks and additional wedges. The short lengths eased the rapid passage of the relining pipe into the existing concrete pipe. After installation, the annulus between the deteriorating concrete sewer and the Corrugated Steel Pipe liner was grouted.

3050mm concrete storm sewer relined with Corrugated Steel Pipe, 2850mm inside diameter employing a 125x25mm corrugation, manufactured from 4.2mm gauge galvanized steel.

The solution selected, which provided the required strength and durability, was a Corrugated Steel Pipe, 2850mm inside diameter employing a 125x25mm corrugation, manufactured from 4.2mm gauge galvanized steel. Due to the fact that the liner had to negotiate a curve in the sewer in order to reach its final location, the length of each pipe section was limited to 3150mm, with a total of 62 sections of pipe being supplied on the contract.
