Shamrock Lake Tunnel Liner Plate

OWNER	Ministry of Transportation Ontario
CONTRACTOR	Teranorth Construction
ENGINEER	Hatch
LOCATION	Highway 11, Shamrock Lake, ON

3700 x 2360 mm 2-Flange Tunnel Liner Plate
Horizontal Ellipse with Polymer Coating

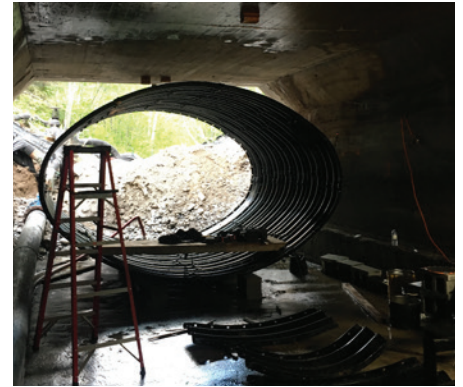
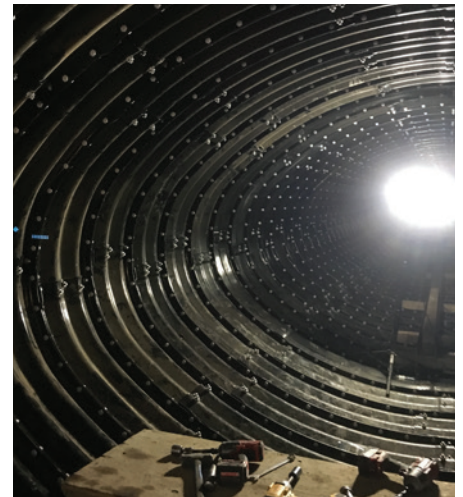
The first stage of the installation involved cleaning out the old box culvert and pouring a new concrete floor. The existing structure was eroded and full of washed up rocks. With that complete, assembly of the Tunnel Liner Plate progressed completely from within the culvert. Shoring and blocking were used as the final stage before grouting. Since the invert of the existing concrete structure was heavily deteriorated, Armtec designed an invert beam to be welded at the bottom of the new liner, for the structure to be blocked against and to support the shoring jack force that fed through the socket at the obvert. Once grouting was complete and the shoring jacks removed, substrate retention sill plates were installed along the length of the culvert to reduce flow velocities and provide rest areas for fish travelling upstream.
